STRUCTURAL INSPECTION

WIMBOTSHAM VILLAGE HALL
LOW ROAD
WIMBOTSHAM
NORFOLK
PE34 9QG

JOB No. 167625

DATE : OCTOBER 2016

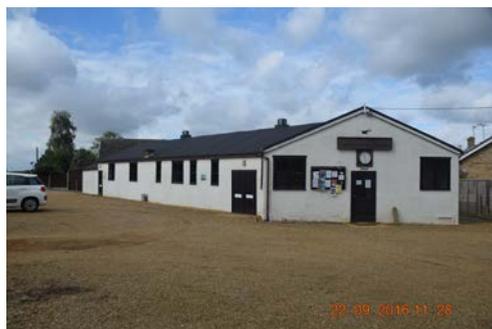
Photo 1 – Front north eastern elevation and eastern gable elevation containing main front entrance door

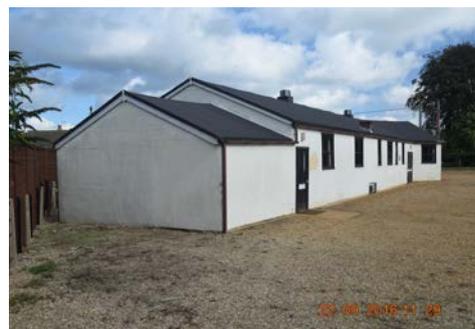
Photo 2 – Photo from the south west showing main hall and store extension

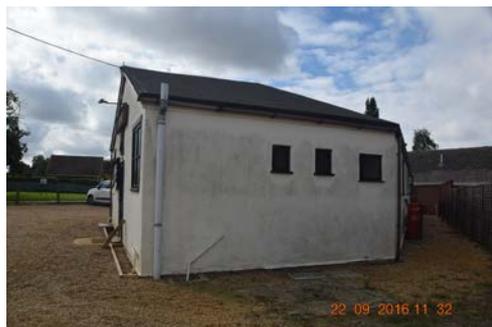
Photo 3 – Northern elevation

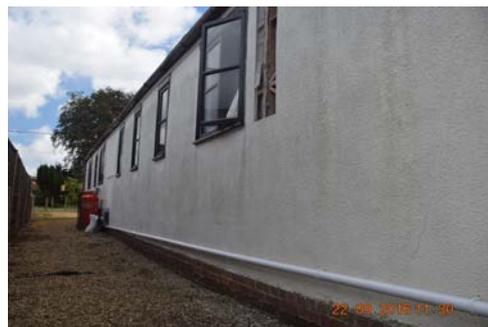
Photo 4 – North western elevation showing low level rising brick plinth

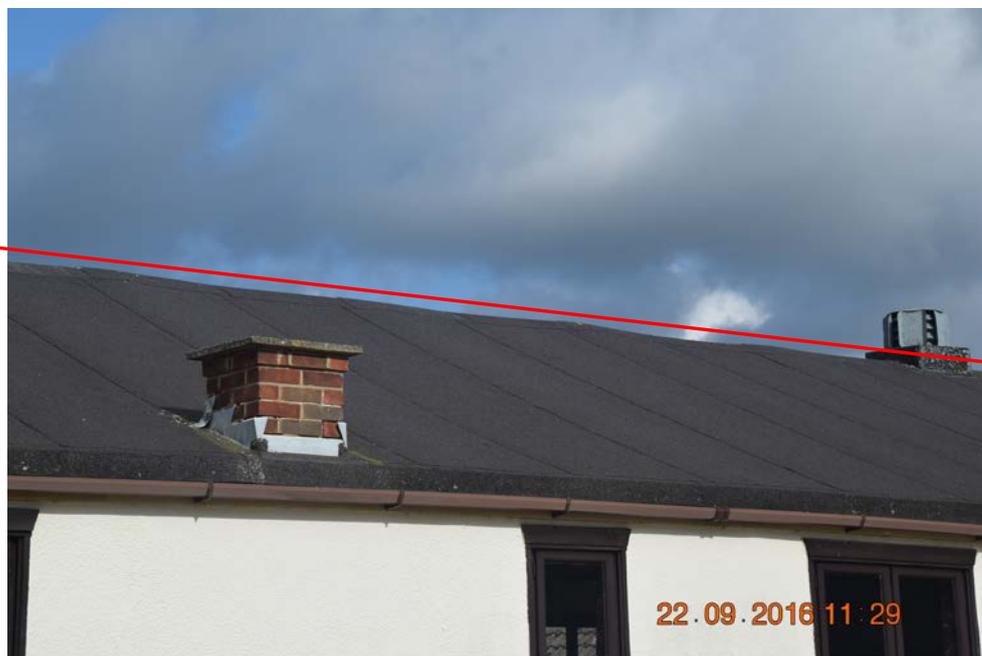
- 3.3 The roof over the main building undulates along the length of the front roof pitch. This can be seen on the main roof pitch as well as at ridge. The high point in the undulations correspond with the timber trusses internally and the undulations between the trusses are the result of the roof structure between the trusses sagging. The extent of the deflection in the roof structure between the trusses can clearly be seen in photos 5 and 6 below.

Photo 5 – Undulations in ridge over main hall

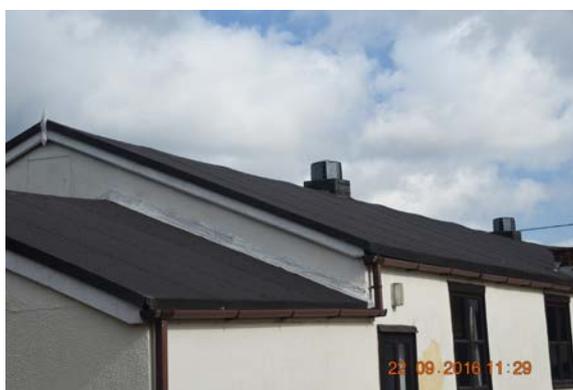
- 3.4 The flashing at the abutment of the lower roof over the store to the original south western gable of the main hall building appears to have been repaired in a rudimentary manner potentially using self-adhesive flash band. The arrangement of this flashing should be improved upon, see photo 6 below.

Photo 6 – Rudimentary arrangement of flashing between roof over store and main hall. Undulations in ridge of main roof also clearly evident in this photo.

- 6.1.4 The flashing between the roof of the store and the gable wall of the original building appears rudimentary and will need attention in the short term.

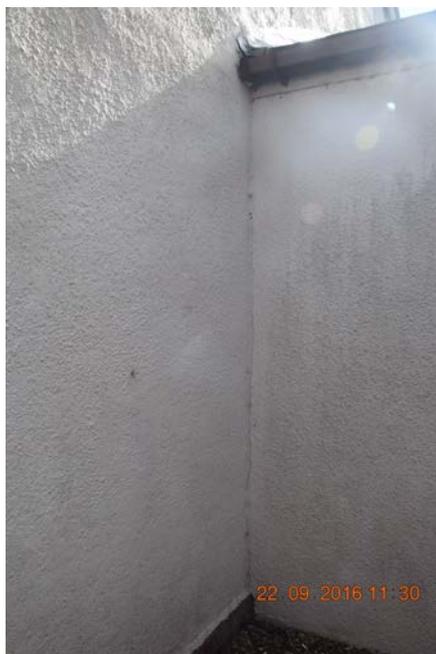
- 3.5 In the western internal corner created where the store extension abuts the original south western gable of the original building there is a vertical joint which has been filled in the past. This joint will need regular attendance to maintain watertightness at this junction, see photo 7 below.

Photo 7 – Vertical joint at junction of store extension with main hall

- 6.1.8 The connection of the rear store wall with the main hall gable wall needs to be maintained weathertight and ongoing maintenance in terms of filling the crack at this junction should occur.

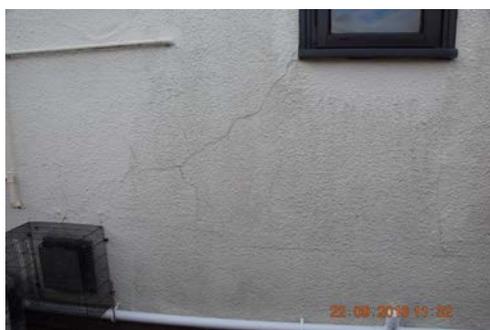
- 3.6 The rear north western and northern elevations of the main hall also contain numerous fine cracks in the external render, see photos 8 and 9 below.

Photo 8 – Fine cracking in rear north western elevation

- 6.1.6 All cracks in the existing render need to be made watertight to prevent water ingress and potential rot of the timber structure. Local repairs and redecoration should be sufficient to keep the external wall envelope watertight.

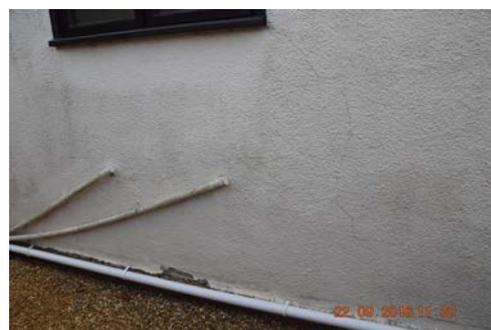
Photo 9 – Typical fine cracking below window in rear north western elevation

- 3.7 The cracks illustrated in the photos above are typical around the external perimeter of the building.

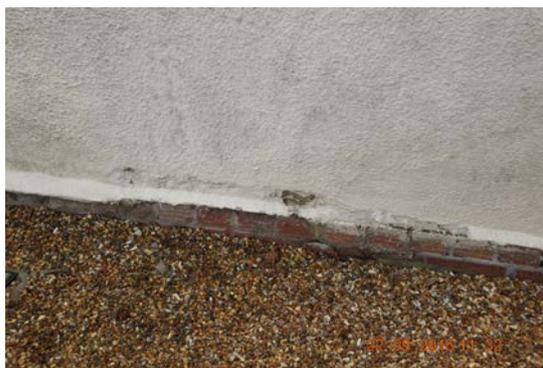
- 3.8 Some damaged render also exists on the rear north western elevation as indicated in photo 10 below, as well as in other areas around the building.

Photo 10 – Damage to low level render on rear north western elevation

- 6.1.9 All guttering should be regularly overhauled and cleared on an annual basis.
 - 6.1.10 The bottom edge of the render at its junction with the low level rising brickwork should be maintained in good condition to prevent water penetration.

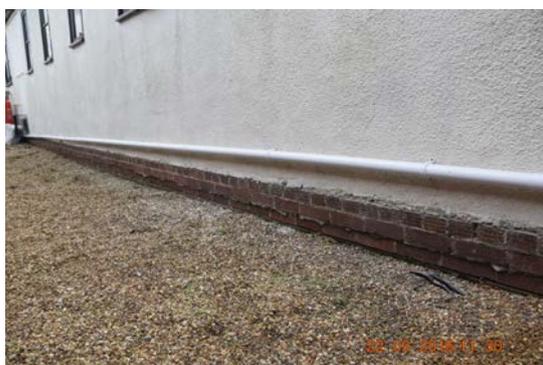
- 3.9 At low level on the rear north western elevation the upper two courses of brickwork oversail the lower rising masonry. This movement in the upper courses of masonry could potentially be the result of lateral expansion of the ground floor slab or expansion / contraction of the low level masonry. We believe both of these potential causes of the movement in the masonry to be unlikely. Expansion and contraction of the low level masonry is unlikely because this elevation faces north west and will not therefore receive significant increases in temperature due to exposure to the sun and there is no evidence internally of lateral expansion movement of the floor slab. It is also the case that the mortar forming the course immediately below the upper two brick courses appears to overhang the rising masonry below and therefore we suspect that the upper two courses were originally constructed in this arrangement due to the fact that the lower rising masonry was potentially misaligned, see photo 11 below.

Photo 11 – Upper two courses of low level masonry oversailing rising wall below

- 6.1.5 The low level brickwork along the rear elevation bows out for the upper two brick courses. Ongoing monitoring of this situation should occur and if the brickwork appears to move further in the future then some remedial attention will be required.

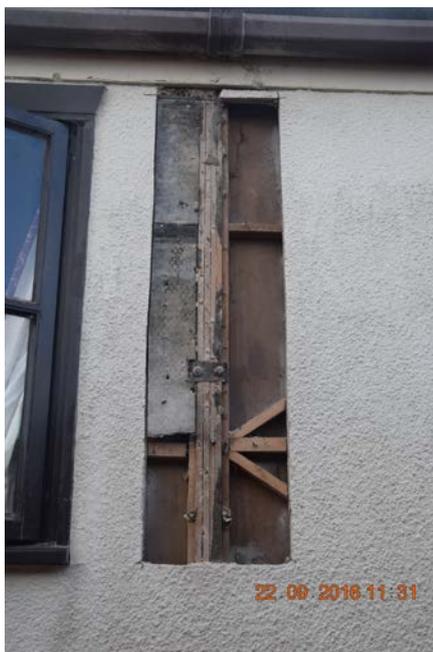
Photo 12 – Section of external render removed at location of internal truss and post at position indicated on drawing 167625 / 01

- 3.11 This revealed a timber post on the line of the truss over the hall internally to be made up of four timber components. The overall depth of the timbers in the wall appear to be approximately 70mm. The two middle timbers are approximately 15mm x 70mm. There is then an additional timber on each side of the central core which is rebated front and back to receive plasterboard. The plasterboard on the outer surface appeared to be 9½mm thick and that on the inner surface 12½mm thick. There was no insulation present between the studs and on the outer surface there was a bituminous building paper onto which an expanded metal lathing had been fixed over which 15mm of render had been applied. The overall thickness of the external walls at high level around the perimeter was therefore approximately 85mm. This width of wall is very slender for a building of this size and type.

- 3.12 At the location where the render had been removed there was also some diagonal bracing present in the plane of the wall and no rot was noted in any of the timbers at this specific location. Part way up the multiple stud there were two bolts and a steel plate noted. These correspond with a bracket internally on this column which fixes a steel post internally to the multiple timber stud, as described further on in this report and as shown in photo 17.

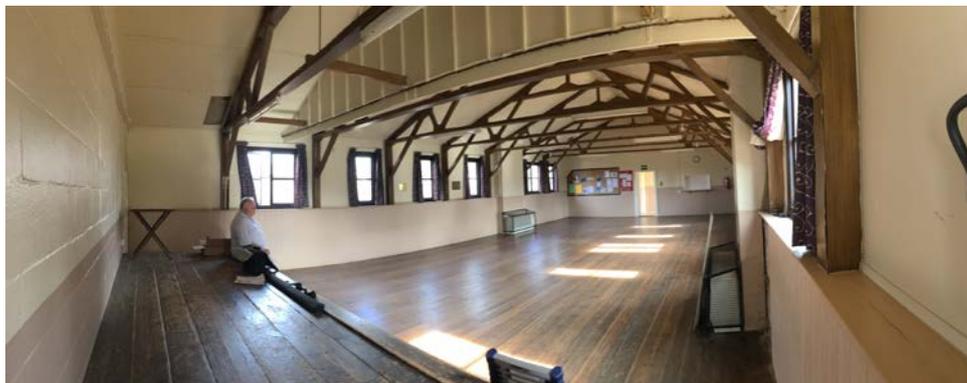
Photo 13 – Internal view of the hall from the southern corner adjacent the stage

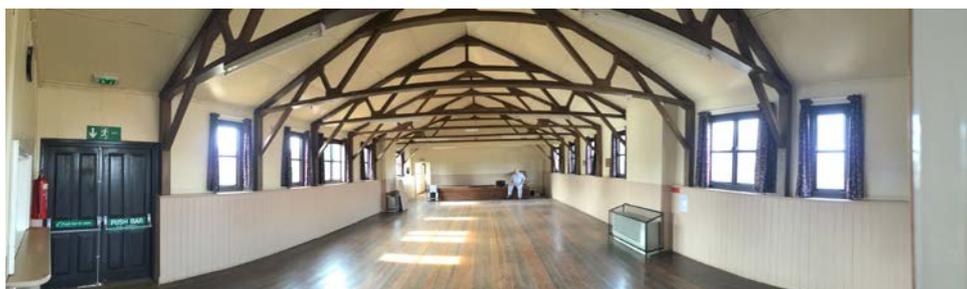
Photo 14 – Internal view of the hall from the north eastern end

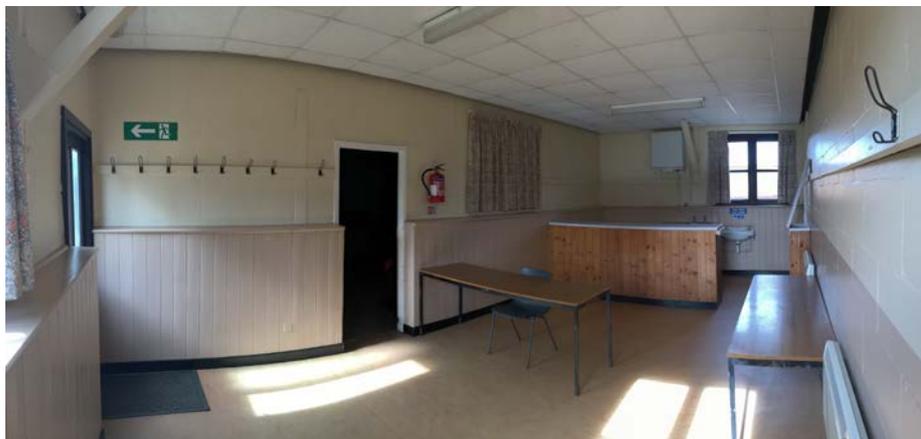
Photo 15 – Internal view of bar

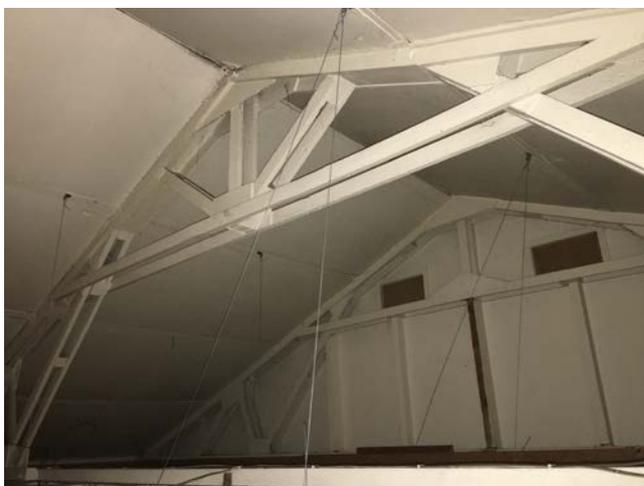
Photo 16 – View of roof structure over bar looking towards the main hall

- 4.6 The truss over the bar is slightly different to that over the main hall in that it has not been clad with additional plywood or hardboard cladding to improve its appearance. The truss over the bar area is therefore the original format of the trusses in this building. It can be seen from this truss how these structural members were formed by building up various components with multiple timbers with spacers and additional plywood gussets at joints. In the hall various sections of these members have been overclad I believe to create a more aesthetic appearance for the main hall. It can also be seen in photo 12 above that additional vertical studs were added to the truss at the end of the hall in order to facilitate overcladding the truss above the masonry wall below.

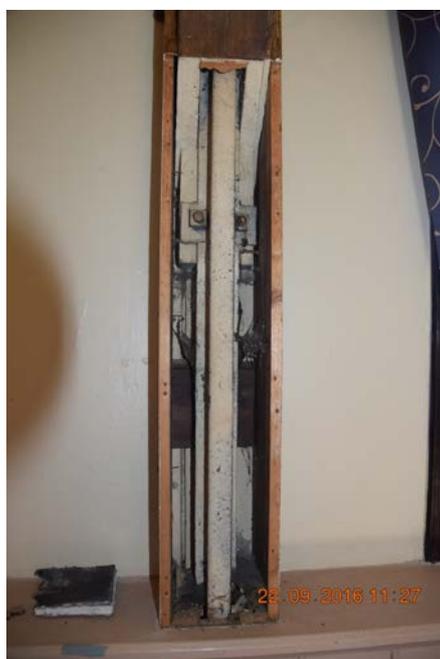
- 4.9 Internally some sections of the existing structure were opened up by Mr John Clark for our inspection, as indicated on drawing 167625 / 01. Cladding was removed to a column on the rear elevation as indicated in photo 17 below. This revealed the inside face of the multiple timber stud described within my external inspection notes with the addition of a vertical steel column bolted to the inside face of the timber member. The connection of the steel to the timber was via the bracket described in paragraph 3.12. The steel section appeared to be a piece of small gauge railway line. The steel appeared to extend upwards beyond the knee brace visible in the photo and the extent of the bottom end of the steel was also unclear from the section of column that was revealed. It is not clear from our inspection whether the steel column exposed and illustrated in photo 17 is an isolated repair or forms part of the structure elsewhere.

Photo 17 – Column on rear elevation adjacent to the stage

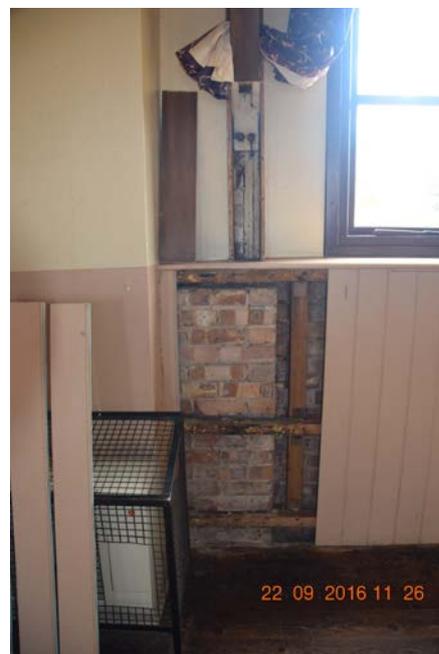
Photo 18 – Column and low level wall exposed on front elevation adjacent to the redundant fireplace

- 4.10 The column immediately adjacent to the redundant fireplace on the front elevation was exposed for inspection together with a section of the low level wall, all as indicated in photo 18 above. At this location this revealed what appeared to be 9" wide brickwork directly below the timber column with a horizontal timber plate located above the brickwork. It was not clear whether or not the multiple timber column continued below the timber plate and into the front face of the 9" brickwork. The brickwork appeared to reduce in thickness immediately to the side of the column where additional vertical timber studs were placed between a horizontal sole plate and the upper timber head plate with horizontal battens in line with the head plate above to provide support to the vertical timber matchboard cladding. It is of note that some of the timbers in this exposed area were partially rotten. It is also of note that there appeared to be some possible rot in the matchboard cladding.

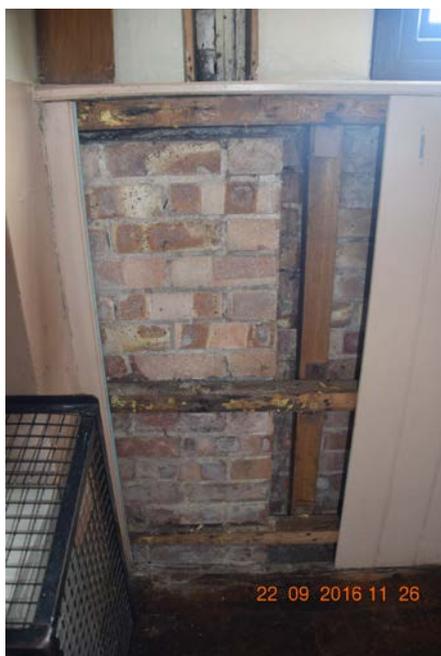
Photo 19 – Low level wall adjacent to redundant fireplace with horizontal timbers containing some rot

- 6.1.7 Prior to contemplating any significant expenditure on the existing building we would recommend that a thorough inspection of all timber elements is undertaken.

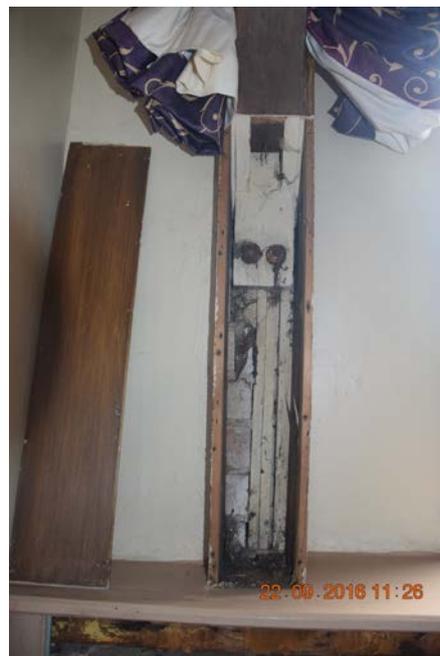
Photo 20 – Timber column above low level wall indicating multiple timber stud and steel bolts but no reinforcing steel column

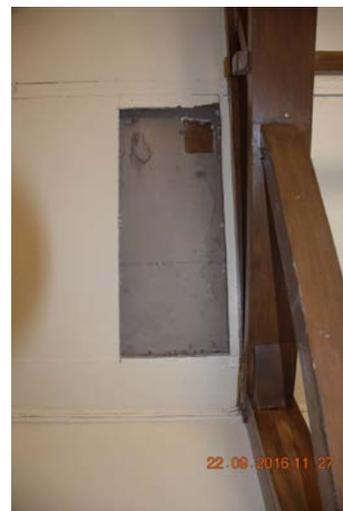
- 4.11 In addition to the exposure of the external walls, a section of ceiling was removed at the location indicated on drawing 167625 / 01. This revealed a make-up very similar to the external wall make up where twin recessed timbers form each purlin spanning between the principal trusses. The lower plasterboard fixed into the lower recess was 9mm in thickness and the upper plasterboard appeared to be 12½mm thickness. Above the upper plasterboard there appeared to be sawn boards of unknown thickness. Between the boards and the upper plasterboard there was a layer of bituminous building paper. We suspect that the bituminous building paper (vapour membrane) passes over the roof and over the external surfaces of the walls to create a complete vapour barrier, although this was not proven by inspection, see photo 21.

Photo 21 – Section of internal ceiling removed in hall for inspection
